## Fletcher Moorland Ltd

### Electric Motor Repair Specification

Controlled Document - Fletcher Moorland Ltd  
V3.0 February 2011 (supersedes all previous documents)

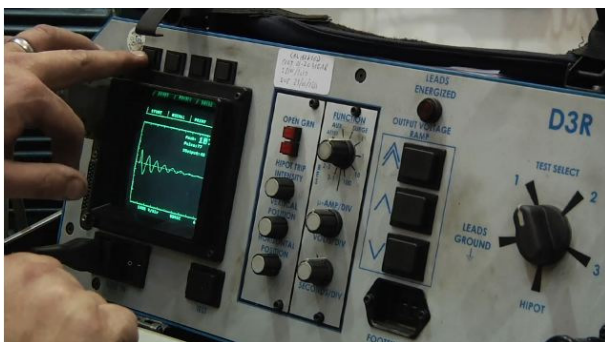
*Baker surge comparison testing to ensure winding integrity*

- 3.1. A full test of the winding condition shall be carried out with the motor stripped down. The Baker surge test unit is to be used to carry out the following tests –

- 3.1.1. Winding resistance comparison tests (There shall be no more than 5% difference between the winding resistance readings)
- 3.1.2. Insulation resistance (IR) test @ 500v (The IR test should be  $200M\Omega$  minimum to earth)
- 3.1.3. Baker Surge comparison @ Line voltage + 1000v (The traces of the comparison test should be equal and superimposed on the display and not jumping)

- 3.1.4. DC High Potential (Hi-Pot) test @ Line voltage + 1000v (This test is for one minute and the leakage current should reduce towards zero during this time. The operator should look out for erratic or jumping readings that could indicate weak ground-wall insulation)

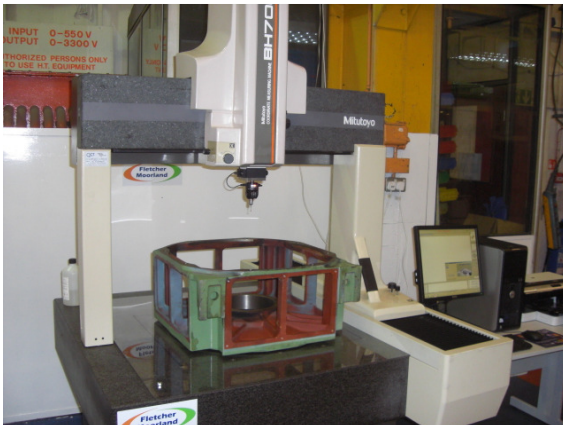
*Measurement to 0.001mm achieved  
using a Mitutoyo CMM.  
Critical to ensure correct OEM bearing  
tolerance fit.*

- 4.1. Bearings shall be removed from the rotor and examined for condition and/or failure mode. All failure modes shall be classified in accordance with ISO 15243 : 2004.
- 4.2. The bearing housings and journals shall be measured to ensure correct size and fit to ISO tolerance. Measurements are to be taken by personnel trained in the use of the Mitutoyo CMM.

- 4.2.1. Journal measurements to be carried out using the Mitutoyo CMM,
  - 4.2.2. Housing measurements to be carried out using the Mitutoyo CMM.
  - 4.2.3. Measured dimensions are to be checked against nominal size and ISO fit. A print off for each measured part (graphic and table) is to be added to the repair report.
- 4.3. Shaft extension run-out is to be checked and should not exceed 0.02mm for 1500 & 3000 rpm machines & 0.05mm for machines below 1500 rpm. Measure and check the condition of the keyway.
  - 4.4. The rotor is to be checked for broken bars, cracked end rings and general condition.
  - 4.5. All mechanical parts are to be thoroughly cleaned and inspected for defects, cracks or damage. Acceptable cleaning methods include steam pressure cleaning, shot blasting, solvent cleaning and immersion washing. Ensure all motor cooling fins are clean and free of debris.

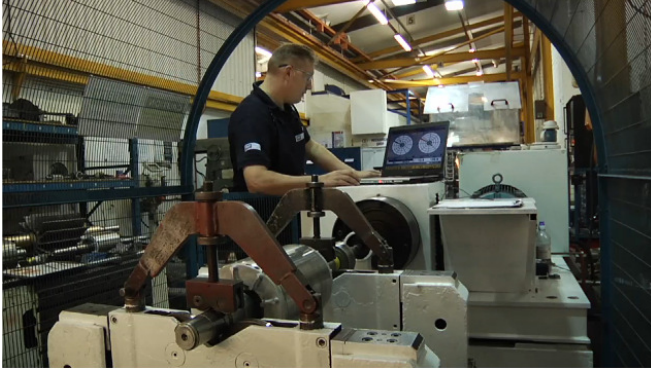
*Rotor balancing to G1.0 for reduced machine vibration, quieter operation, increased efficiency and longer life*

- 4.6. All rotors are to be dual plane dynamically balanced to achieve grade G1.0 (ISO 1940-1) or at least Grade G2.5. All balancing is to be half-key.

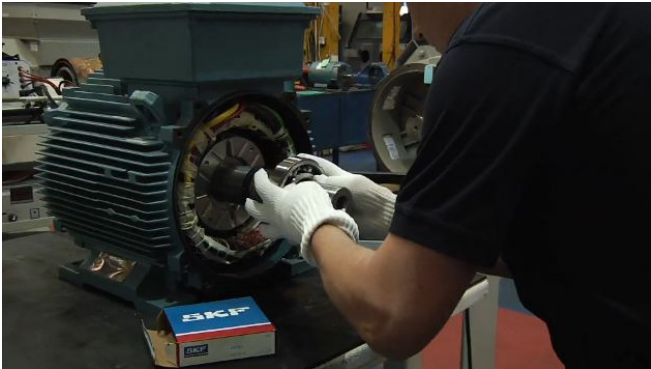
*Correct bearing fitting methods and procedures to ensure long motor life*

- 6.2. Only SKF bearings are to be fitted to a motor and the SKF fitting procedures should be followed at all times. Only use an approved bearing induction heater, temperature controlled and with a degaussing function.

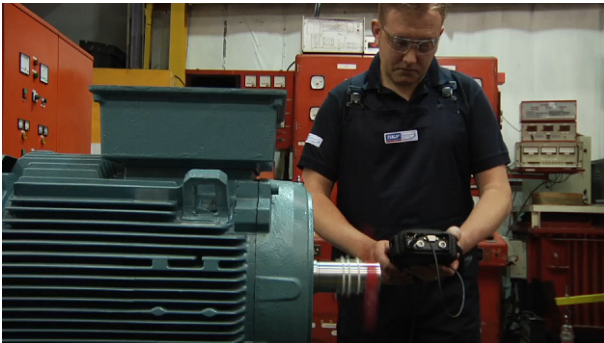
*Final motor test run following repair*

- 7.1. Motor testing is to be carried out on an isolated test bed.
- 7.2. The motor is to be run at nameplate voltage, frequency and speed. Record the current drawn per phase and document.

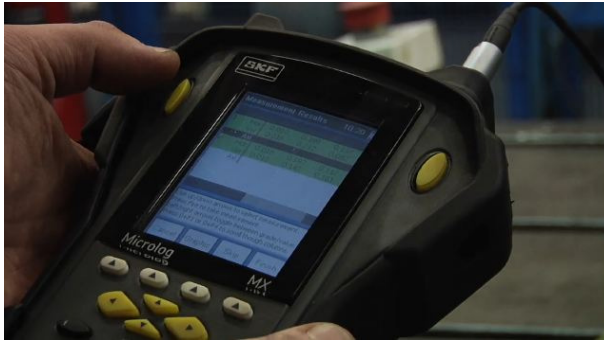
*SKF Mx Microlog used for motor  
vibration acceptance testing*

- 7.3. The motor shall be vibration acceptance tested. Using the SKF Mx Microlog conformance checker, carry out a vibration test in the vertical, horizontal, and axial planes on the DE, Vertical and horizontal planes (at least) on the NDE. Record the vibration spectrum for each position measured.

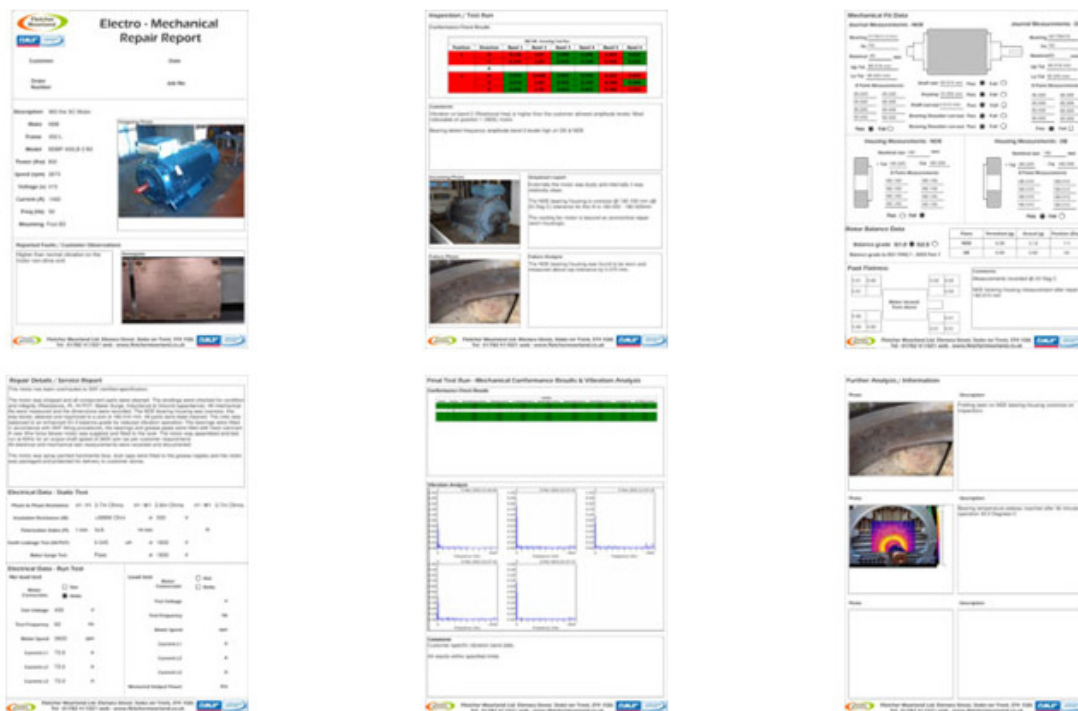
### Repair report example

The repair report example consists of six screenshots:

- Electro-Mechanical Repair Report:** The main title page with fields for Customer, Date, and Job No. It includes a photo of the motor and a list of specifications: Model: 300, Frame: 300, Motor: 300, Power (kW): 30, Voltage (V): 230, Current (A): 100, and Frequency (Hz): 50.

- Mechanical Fit Data:** A detailed table of mechanical fit measurements for various parts, including dimensions and tolerances.
- Repair Details - Service Report:** A text-based section providing a detailed description of the repair work performed, including the root cause analysis and the steps taken to resolve the issue.

- Further Analysis - Information:** A section containing additional information and photos related to the repair, including a photo of the motor's internal components and a photo of the motor's nameplate.

9.1. To complete the repair, a full service document must be compiled detailing the following – Incoming inspection and test results, Root cause failure analysis, Bearing condition analysis, Mechanical fit measurements and tolerances, Winding test data, Final tests results & Vibration acceptance results
